# Manhole Inspection Summary

Manhole # S69M\_\_016MH

Insp Date: 1/31/08 1:51 PM

**Location** Address: **1100 Steelton Ave.**

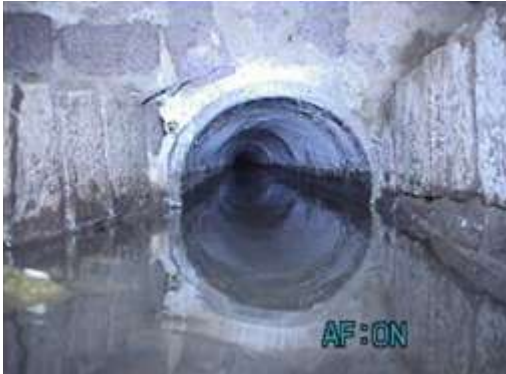
Defect 1

cracked pipe seal 10:00 incoming 3 o'clock

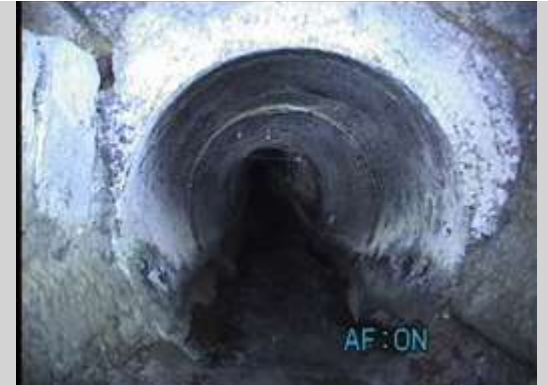
12 O'Clock Outflow

8 in. Circular Gravity Sewer  
Pipe Out @ 12 O'Clock

Pipe Height: **8.4** (in.) Rod and Bar (Angled)  
Pipe Material: **Clay** ☐ Pipe Lined  
Invert Depth: **8.25** (ft.) Flow Characteristics: **Fast**  
Deposits: ☒ None ☐ Mud ☐ Gravy ☐ Debris ☐ Grease  
Silt Depth: (in.) Deposits Extent:  
Infiltration: **None** Pipe Seal Cond: **Sound**

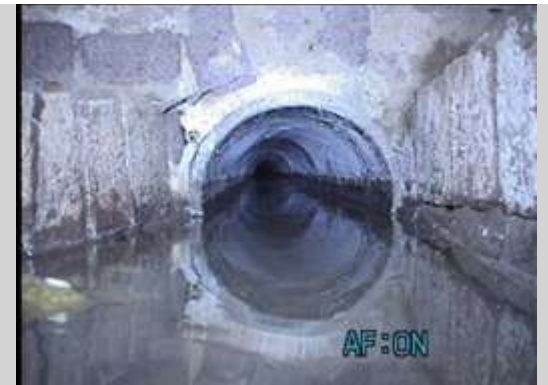
3 O'Clock Inflow

8 in. Circular Gravity Sewer  
Pipe In @ 3 O'Clock

Pipe Height: **8.4** (in.) Rod and Bar (Angled)  
Pipe Material: **Clay** ☐ Pipe Lined  
Invert Depth: **8.17** (ft.) Flow Characteristics: **Slow**  
Deposits: ☐ None ☐ Mud ☒ Gravy ☒ Debris ☐ Grease  
Silt Depth: **4** (in.) Deposits Extent: **Heavy**  
Infiltration: **None** Pipe Seal Cond: **Sound**

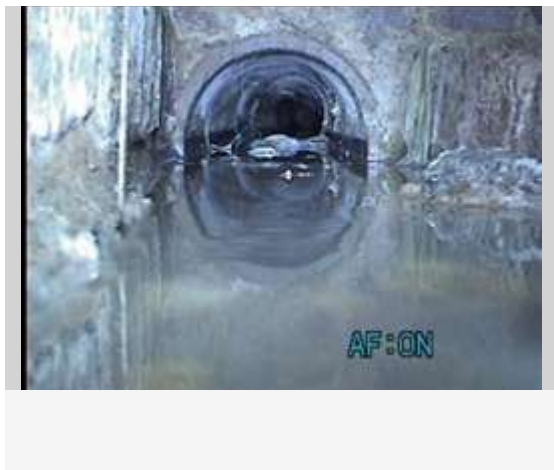
9 O'Clock Inflow

8 in. Circular Gravity Sewer  
Pipe In @ 9 O'Clock

Invert Depth: **8.13** (ft.) Flow Characteristics: **None**

Deposits: ☐ None ☐ Mud ☒ ~~Sludge~~ **Debris** ☐ Grease

Silt Depth: **4** (in.) Deposits Extent: **Heavy**
